# Conservation Management at Dibbinsdale Local Nature Reserve

## F. Babbs Meadow Conservation Diary Notes

# Babbs Meadow Enhancement Scheme Eastern Section (Water Vole habitat project)

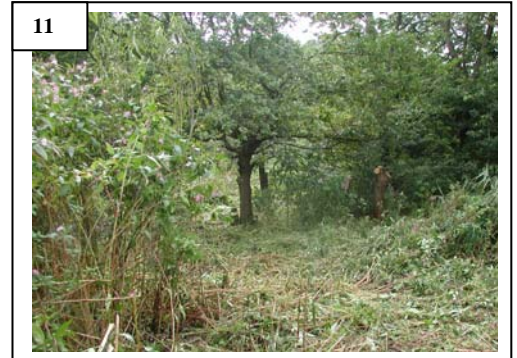
Balsam removed prior to work by contractors

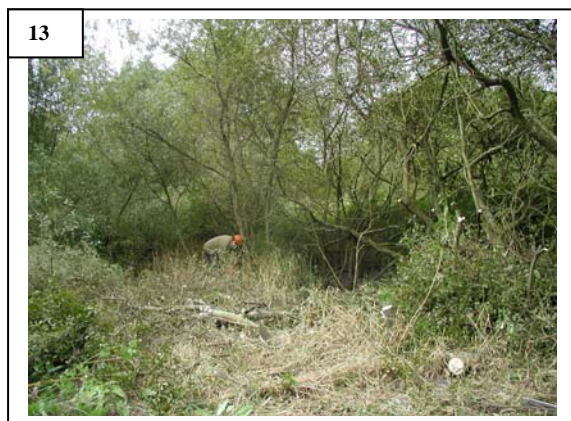
Willow clearance prior to contractors doing excavations

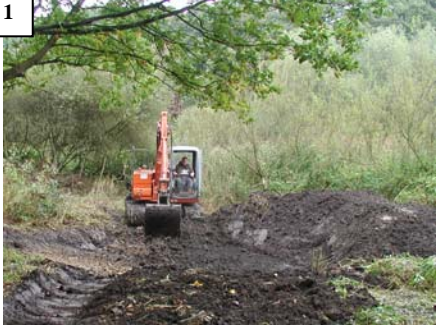
1

North pools being dug close to Central Ave swales

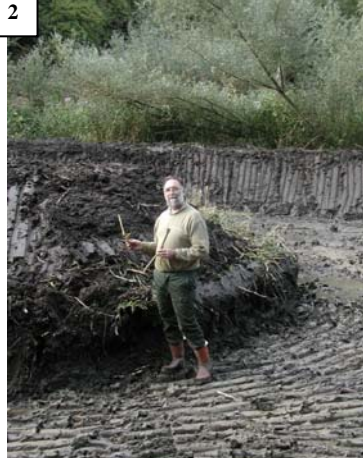
2

South pools dug prior to flooding

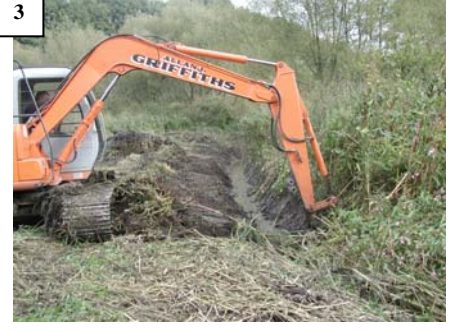
3

The old ditch being dug out and broadened for 'lagoons'

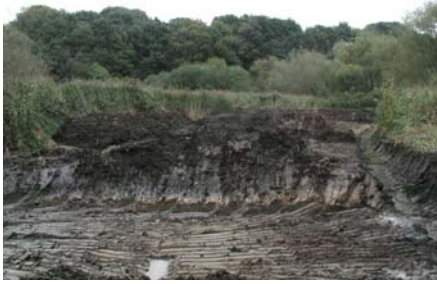
4

The excavations of the lagoons prior to flooding

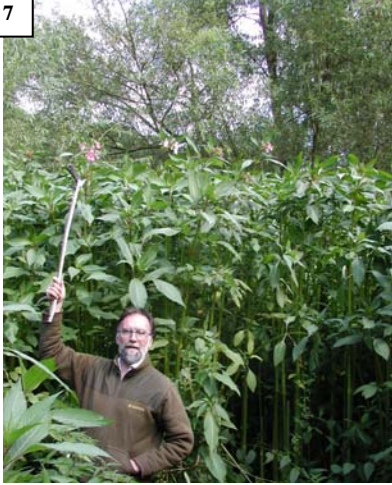
7

Vigorous growth of balsam after excavation work

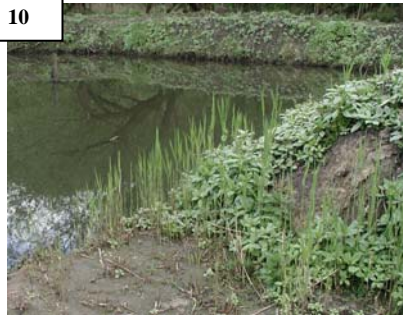
10

New reed growth following excavation

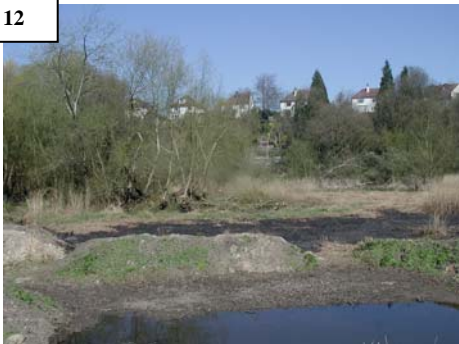
12

Reed cut and burn- the first reed cut followed by arson attack

The routes into the reedbed used by the excavator were fenced off to restrict access by the public. This didn't prevent material from the first reedcut being set fire to at Easter time. Reed regeneration was probably given a helping hand.

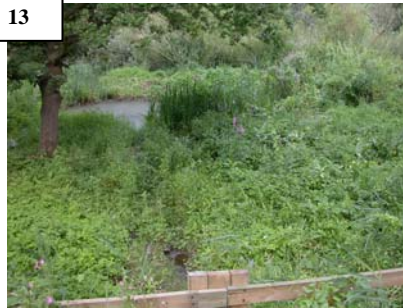
13

Vegetation growth after balsam strimming – one year on

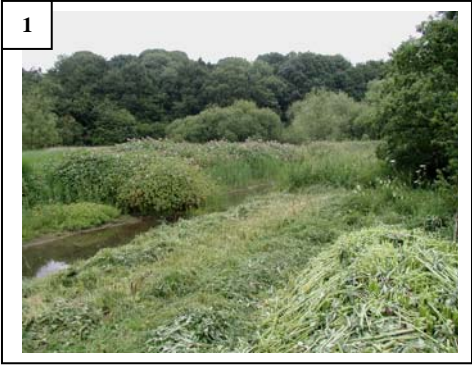
Bank of ditch after strimming out of balsam

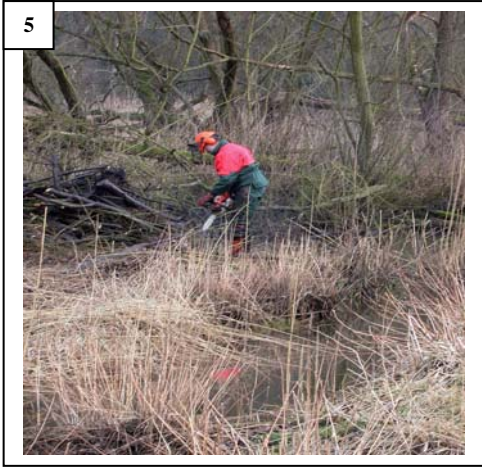
Removal of willow trees close to the river edge

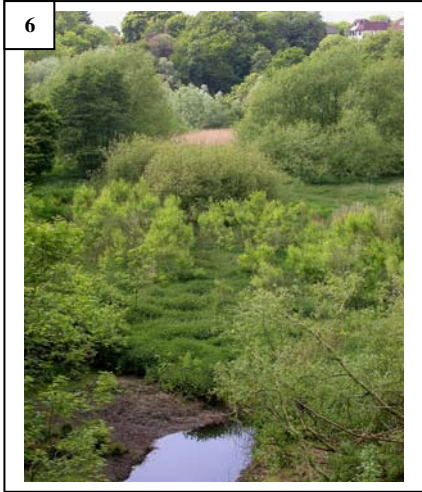
View from the top of the escarpment, noting young willow growth

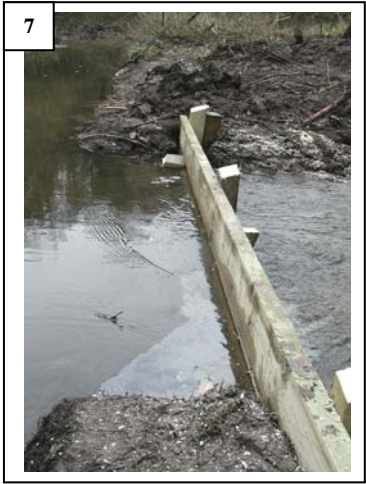
Small weir construction where the ditch join the river

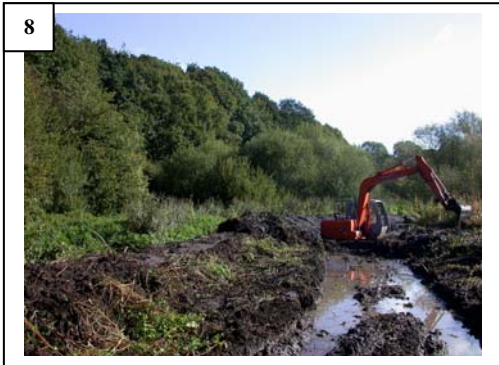
Making the bund to pond the flood water

2004 saw the second phase of reedbed restoration. The small weir was replaced by a more effective sluice gate. A further bund was created the other end of the ditch to keep in floodwaters. (Raising water levels in the reedbed)

A long berm or bank was created to pond water left by the river after flood.

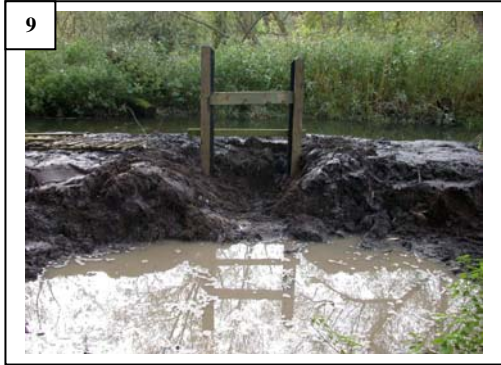
Building of a sluice gate in place of the small weir

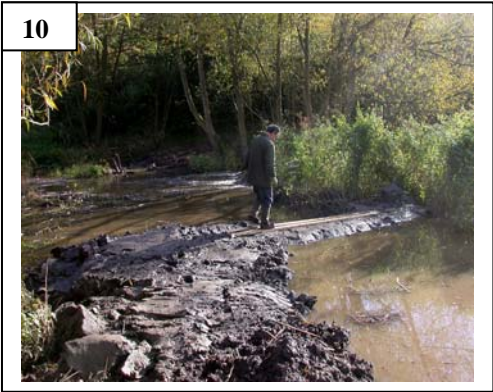
The effectiveness of the weir work as shown after flooding

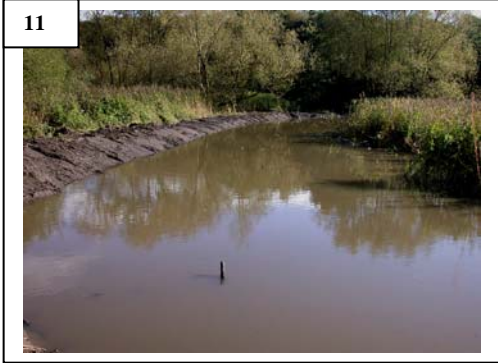
Water levels rise in the reed bed after flooding.  
The bund is on the right

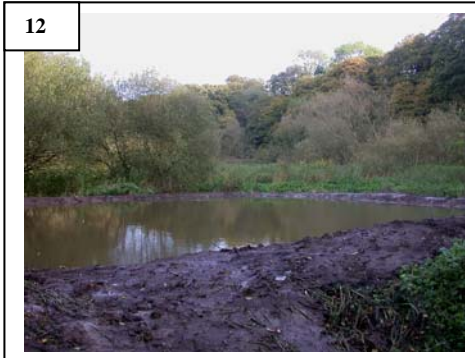
New reed pool is dug underneath the sandstone  
escarpment

A further shallow pool was added underneath the sandstone escarpment and further willows removed.

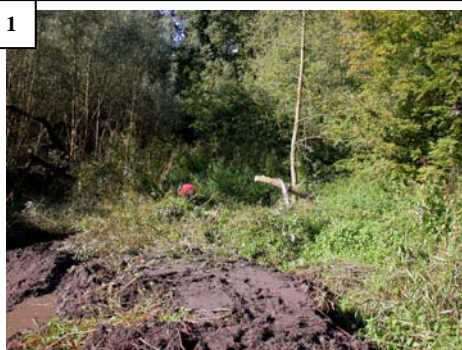
1

Excavator in the corner of the reedbed removing willow stumps

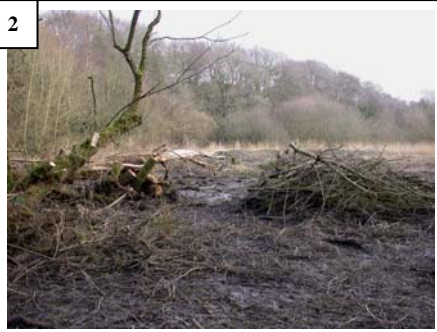
2

Willow stumps and a gap created to allow flooding

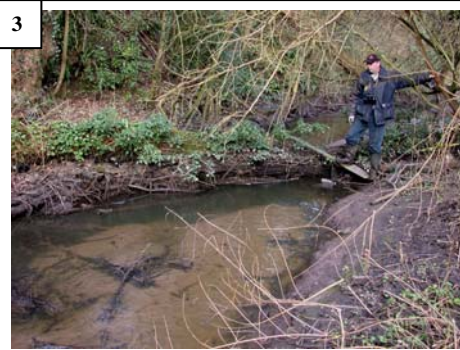
3

Willow tree blocking the channel close to the meander

Work began in 2005 clearing up willows removed by the excavator. It was clear that the river still had severe flow problems and there were many blockages caused by tree fall. River water was now diverting entirely into the reedbed because the river was so badly silted . The year's reed cut took out the section in the middle of the reedbed. Marker posts were driven into the ground. Two more weirs were created to further control water coming into the reedbed from the river and leaving the reedbed When the river flooded after the reeds were cut in February the level of water appeared very good.

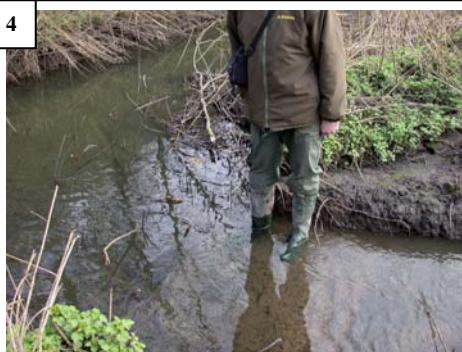
4

Channel needing water control and weir construction

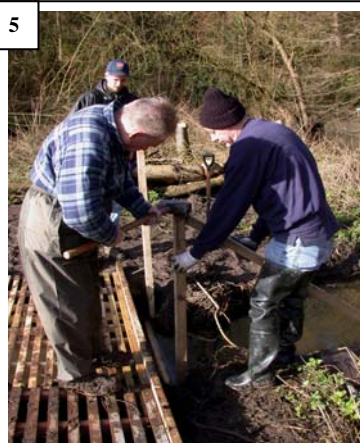
5

Weir being built by volunteers

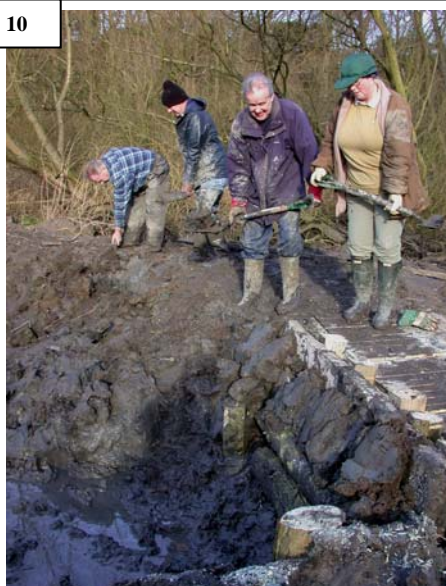
10

Weir constructed downstream to stop water escaping from Babbs Meadow

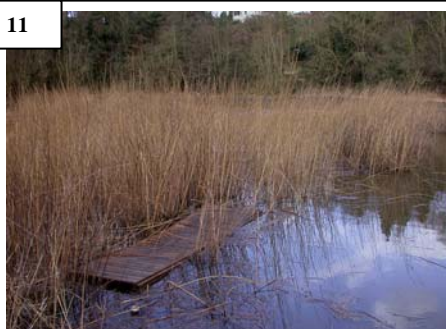
11

Reedbed under flood after weirs built

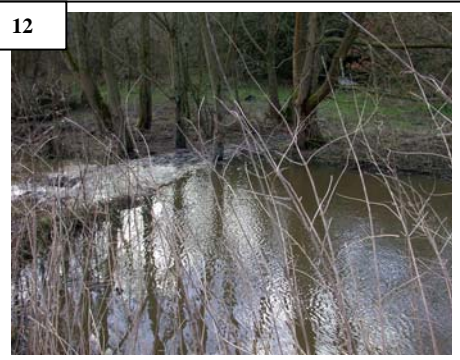
12

Bund after flooding

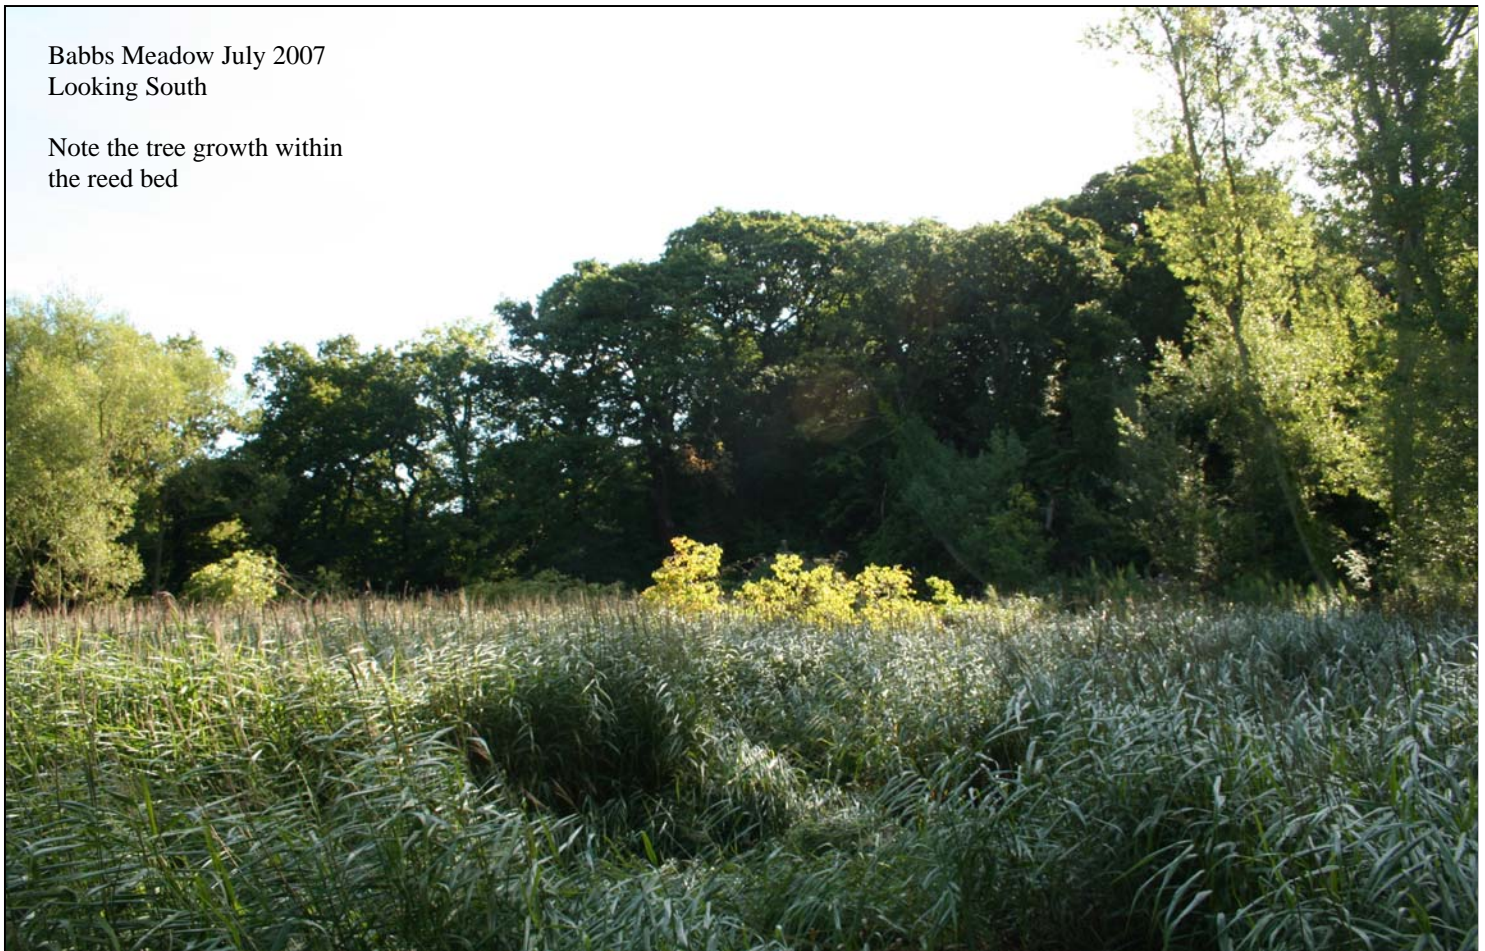
Babbs Meadow July 2007  
Looking South

Note the tree growth within  
the reed bed
