Conservation Management at Dibbinsdale Local Nature Reserve

O.Lady Bridge Wetland Scheme Phase 1.

P.Ladybridge Phase2

**Interim Progress Report
Ladybridge Phase 2 Wetland Scheme
Dibbinsdale Local Nature Reserve-2006- 2007**

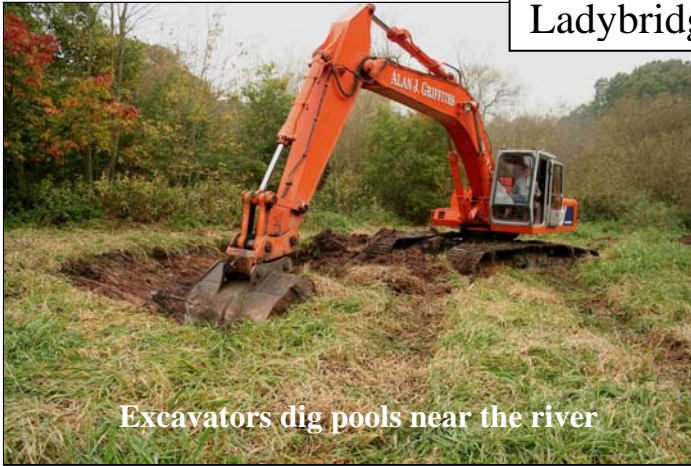
Excavators dig pools near the river

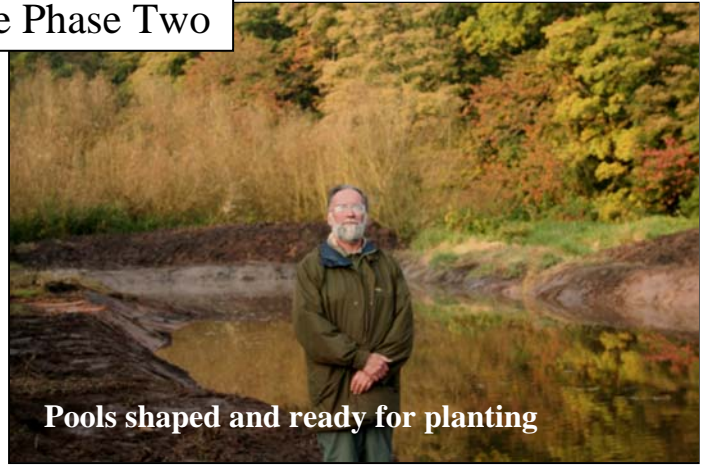
Pools shaped and ready for planting

The shape of the pools is determined by the underground sewer pipe that follows the line of the river. The pipe lies between two manhole covers at the bottom of the meadow. Efforts were made to avoid this and the pool the toads use in spring

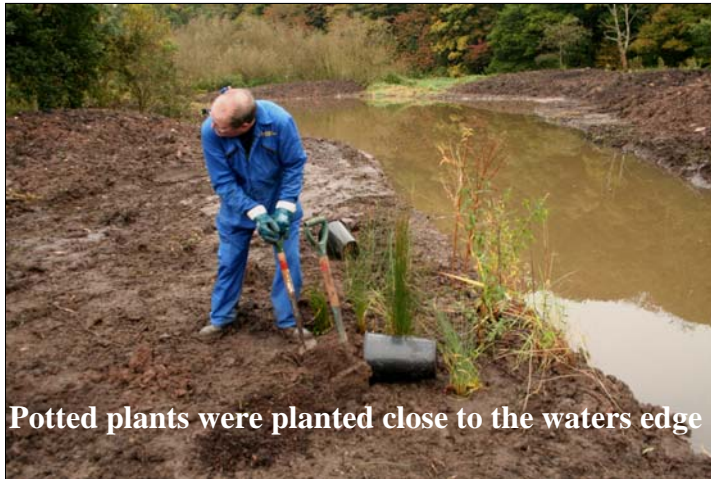
Potted plants were planted close to the waters edge

The 'soft' edge of the pools is an ideal place to plant marginal plants like purple loosestrife, rushes, and flag iris. Access for wildlife in and out of the pools is important

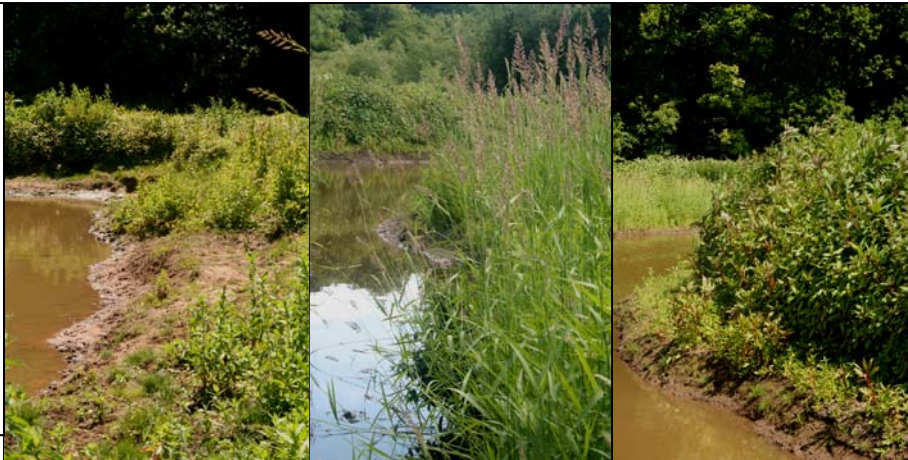
Himalayan balsam (left) was regularly strimmed out in the summer of 2008 so that the plant did not set seed. The middle picture shows the growth of phalaris close to the water in the first summer.

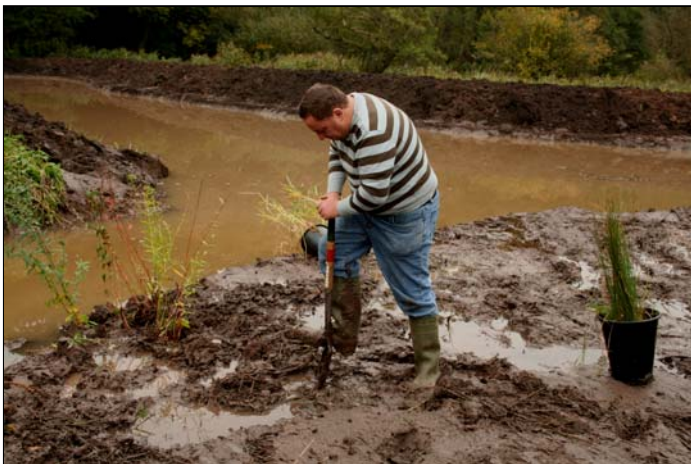
Pool shelf is planted up

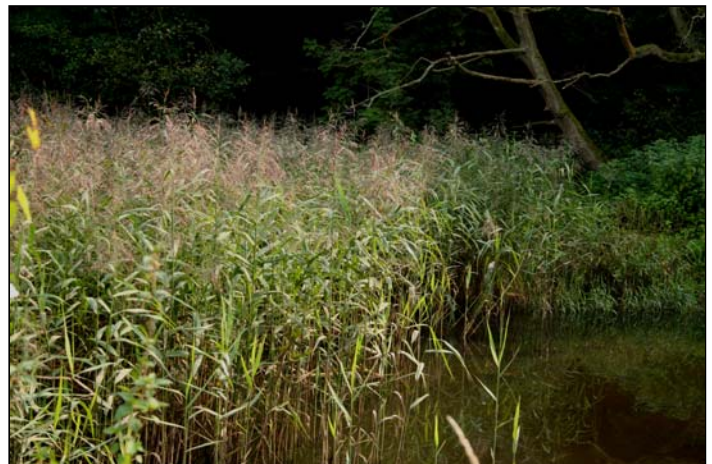
Reed growth by Ladybridge phase one pools

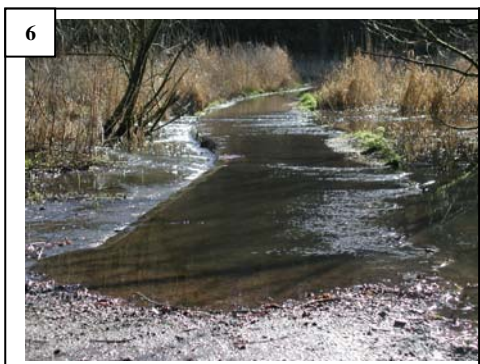
The causeway floods in 2001

- 2** The second feature of the scheme was the causeway that linked Bodens Hey Meadow with the bridge. This was also prone to flooding, particularly in winter. This has now been raised and resurfaced with stone. The access to the bridge is now easier without the need for a step on and off. Excavated material has been used to make the causeway broader and less linear. Water that was held up by the causeway in times of flood can now flow under the path through a pipe that links one wetland area with another downstream.

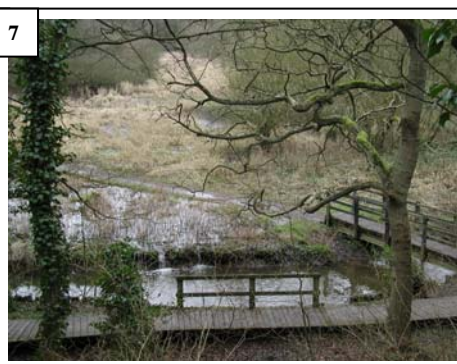
The wooden walkway and Ladybridge after flooding

- 1** A wooden walkway close to the bridge running along the river bank had been decaying for many years. The wooden boards had become uneven, slippery and dangerous- regularly needing replacement and repair. The new path skirting the wooded slope behind the wooden walkway now replaces it. It is a stone path on flood free ground that will be a safer and sounder all season path. Efforts will be made to landscape the river bank in order to stabilize it and make it more natural.

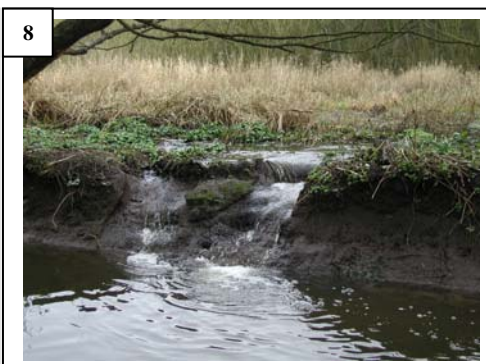
The floodwater returning to the river

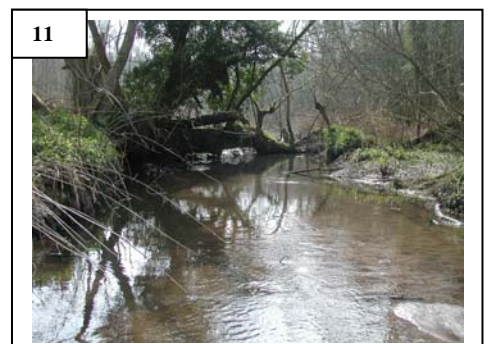
Willow blockage of the Dibbin

Debris has built up in the river just passed the Ladybridge. This has semi blocked the river and has obstructed it enough to cause the meander to be truncated(the water cuts through the meander) This needs to be unblocked and the short cut blocked in turn by debris- 2009

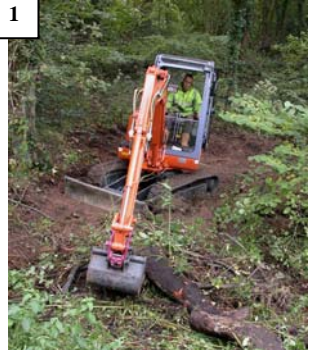
Excavator removes wooden walkway

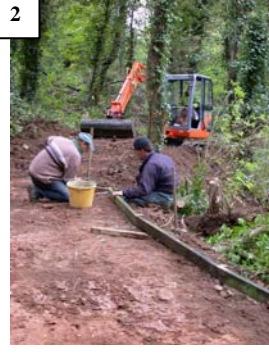
New path edging prepared

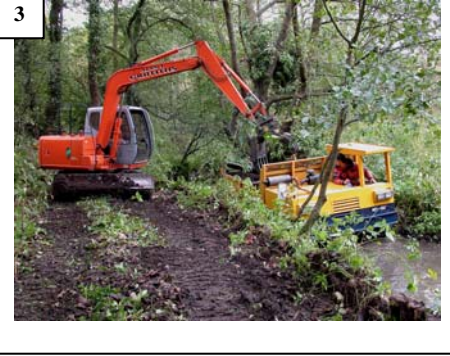
Excavator removes material onto aquatic dumper

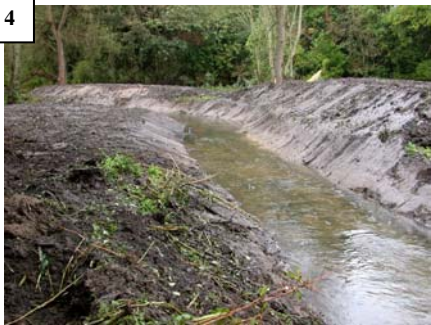
Newly dredged river channel

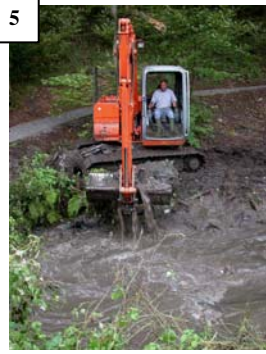
Dredging near to bridge

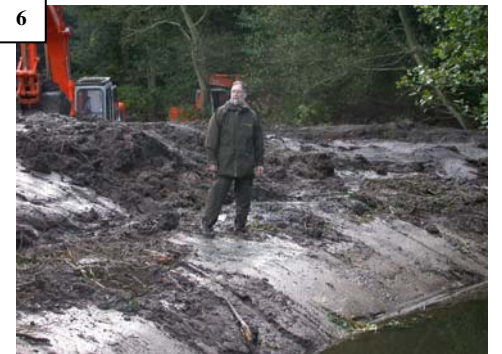
Banks formed with excavated material

- The spoil from the excavated pools has been deliberately piled in high banks along the rivers edge. As with Babbs Meadow Project, the banks will remain above the flood level. This will encourage water voles to recolonise it.

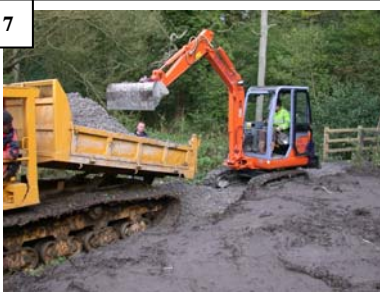
Stone unloaded for the paths

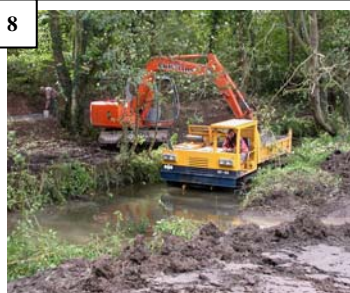
Stone unloaded onto path

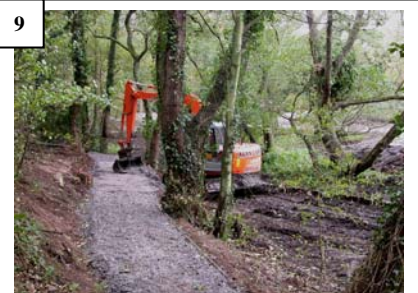
New path under construction

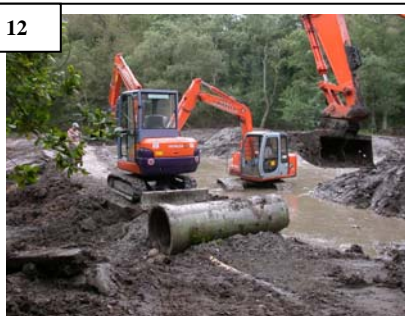
Flood relief pipe being installed

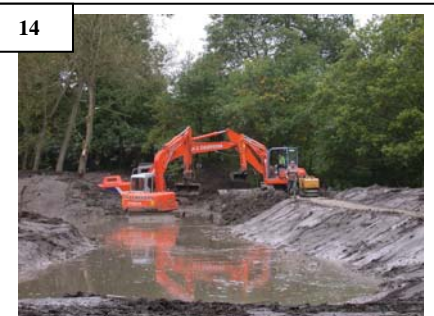
Causeway revetment and firming

Another sewer type concrete pipe installed in the causeway to help the pressure of water building up behind the causeway footpath at times of flood. Work done to also stop footpath material loss in between the two pipes through erosion. Wooden revetment installed.

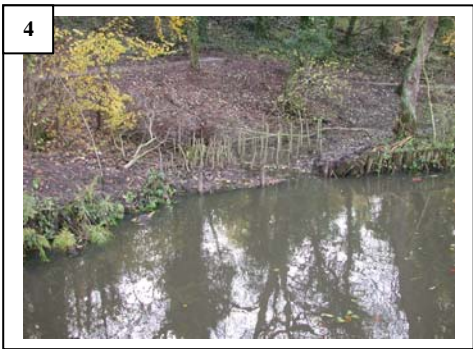
New willow plantings to stabilise the river bank

Willow stakes planted on the Marfords Wood side of the river to help stabilise the bank and stop erosion. This had had little effect and the willows have not taken with any vigor. A clump of Japanese Knotweed needs chemical treatment here in 2009. Injecting ?

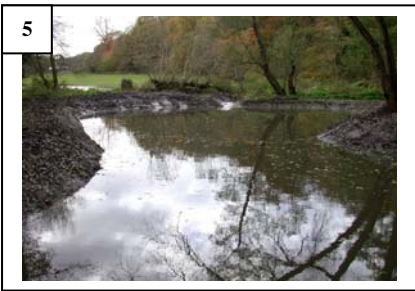
Floodwaters fill the south pool

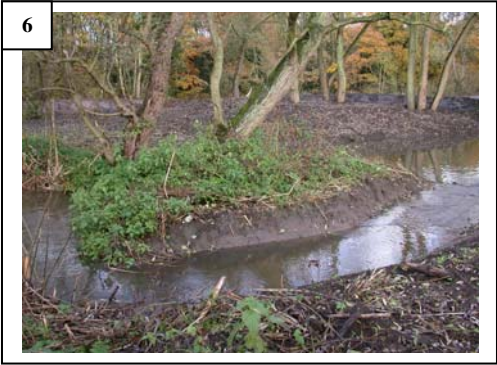
Pools and filters beds fill with water

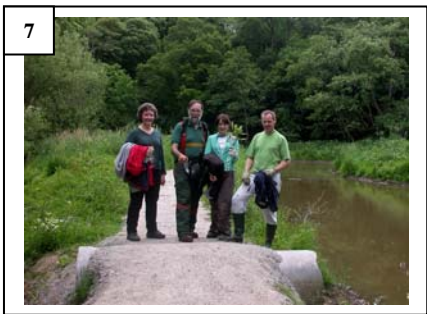
The flood relief pipe in mid summer

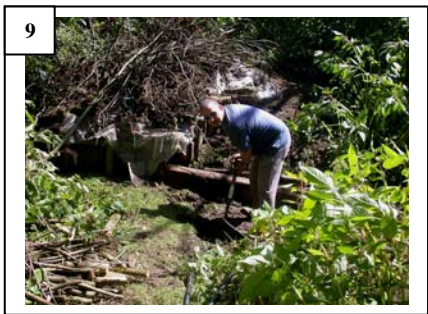
Railway sleepers used to build otter holt

Willows coppiced to make experimental Otters Holt at rear of first pool upstream from Ladybridge (i.e the one furthest downstream). Two level created. Covered with plastic membrane earthed over.

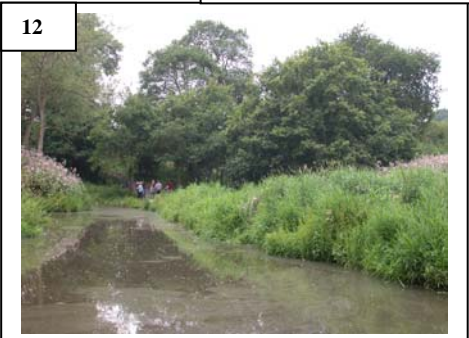
View of the vegetated pcauseway pool in mid summer

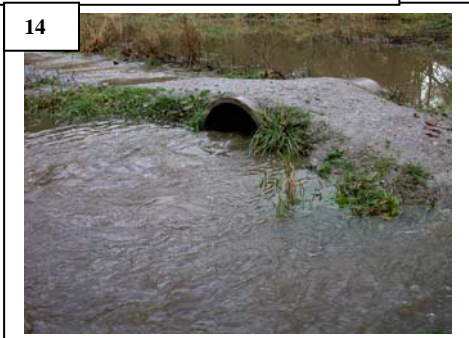
Extreme flooding showing how the causeway copes with water

Though the work has brought some alleviation to flooding here, it is not 100 % effective.
